Manhole Inspection Summary

Manhole # S05UU1014MH

Insp Date: **10/12/06 12:55 PM**

Location Address: **3307 W NORTHERN PKWY**

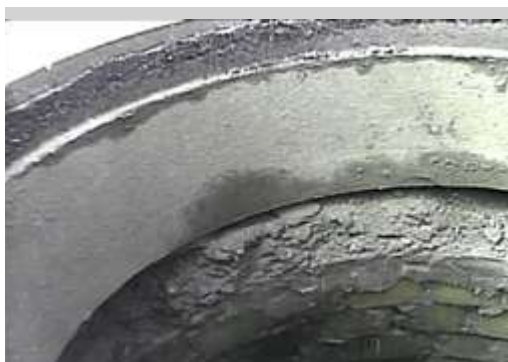
Defect

Frame leaks. Adjustment deterioration. Adjustment and Corbel infiltration.

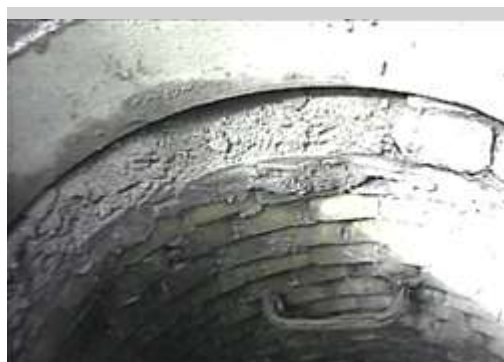
Defect

Frame leaks. Frame offset. Adjustment deterioration and loose brick. Adjustment and Corbel infiltration. Corroded steps.

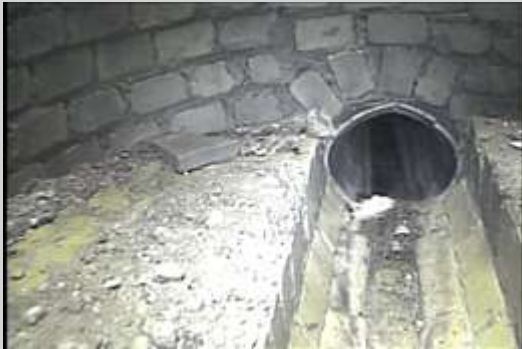
8 in. Circular Gravity Sewer Pipe Out @ 12 O'Clock

Pipe Material: **Unknown** ☒ Pipe Lined

Invert Depth: **8.80** (ft.) Flow Characteristics: **Slow**

Infiltration: **Evidence** Pipe Seal Cond: **Unknown**

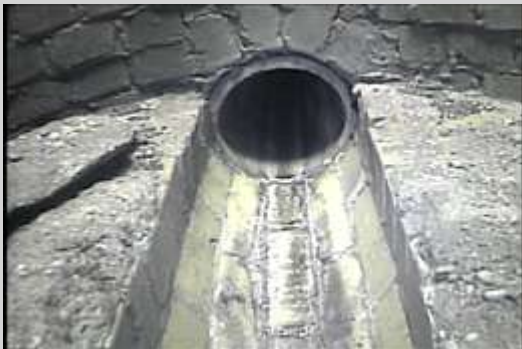
8 in. Circular Gravity Sewer Pipe In @ 6 O'Clock

Pipe Material: **Clay** ☐ Pipe Lined

Invert Depth: **8.61** (ft.) Flow Characteristics: **Slow**

Infiltration: **Evidence** Pipe Seal Cond: **Unknown**
